**AGARD Report No.733
WORKSHOP ON AVIONICS CORROSION CONTROL**

**Papers presented at the 62nd Meeting of the Structures and Materials Panel of AGARD in Høvik,
Norway on 16-17 April 1986.**

AVIONIC CORROSION

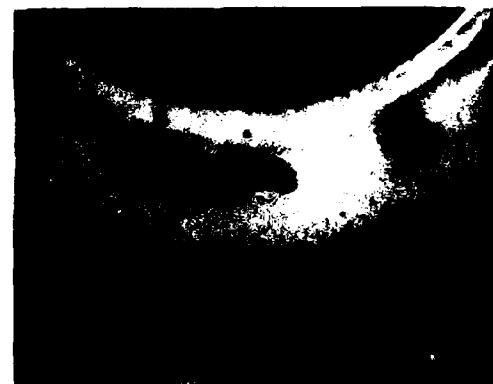
Figure 25. Interior corrosion in the triode. Glass envelope has been removed.

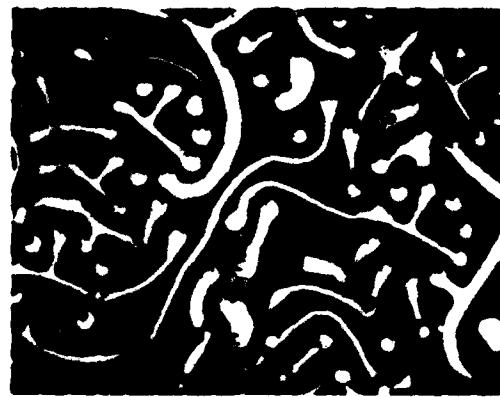
Figure 28. Corrosion on board resulted from chloride contamination. See Figure 29.

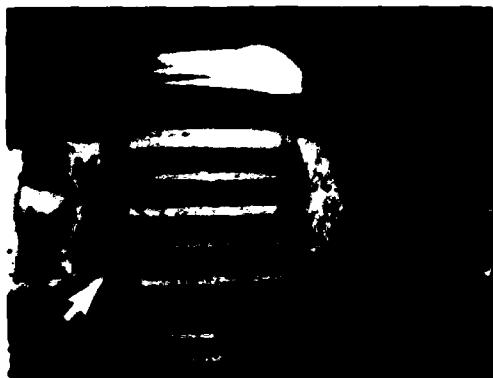
Figure 30. Failed transistor with high surface chloride contamination. See Figure 31. Arrow marks site of open aluminum conductors.

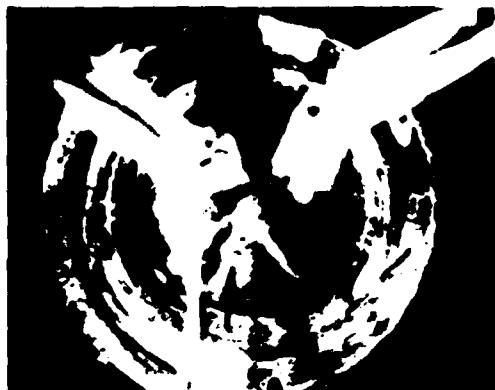
Figure 33. Arrow marks corrosion residue on potentiometer exterior which shorts out electrical leads.

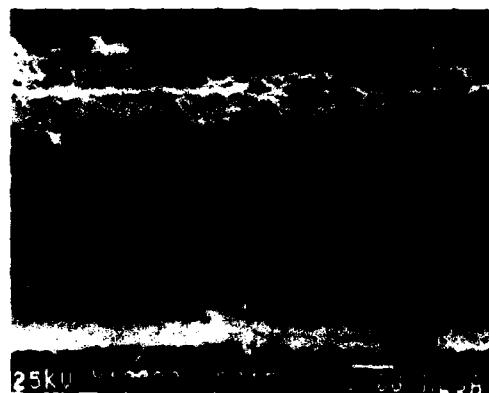
Figure 44. Cross-sectional area of good connector.

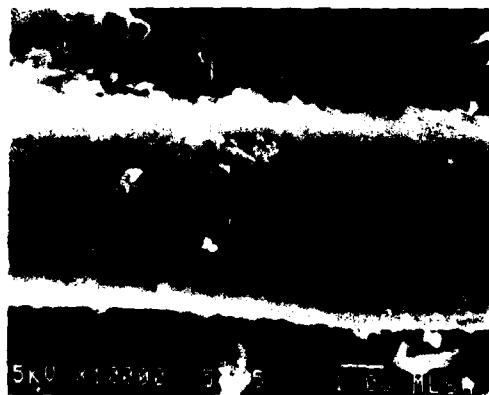
Figure 45. Cross-sectional area of failed connector.

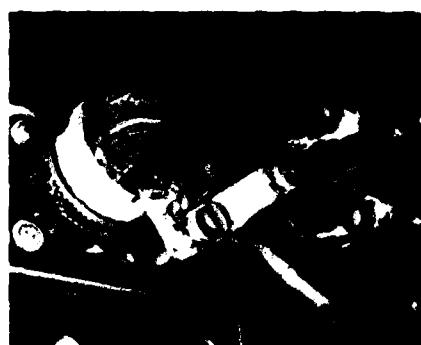
Figure 46. Corroded electrical connector on avionic equipment.
